Opening rear window repair Citroen C5 break

Fault – rear window will not open on rear tailgate due to lack of continuity of track inside window.

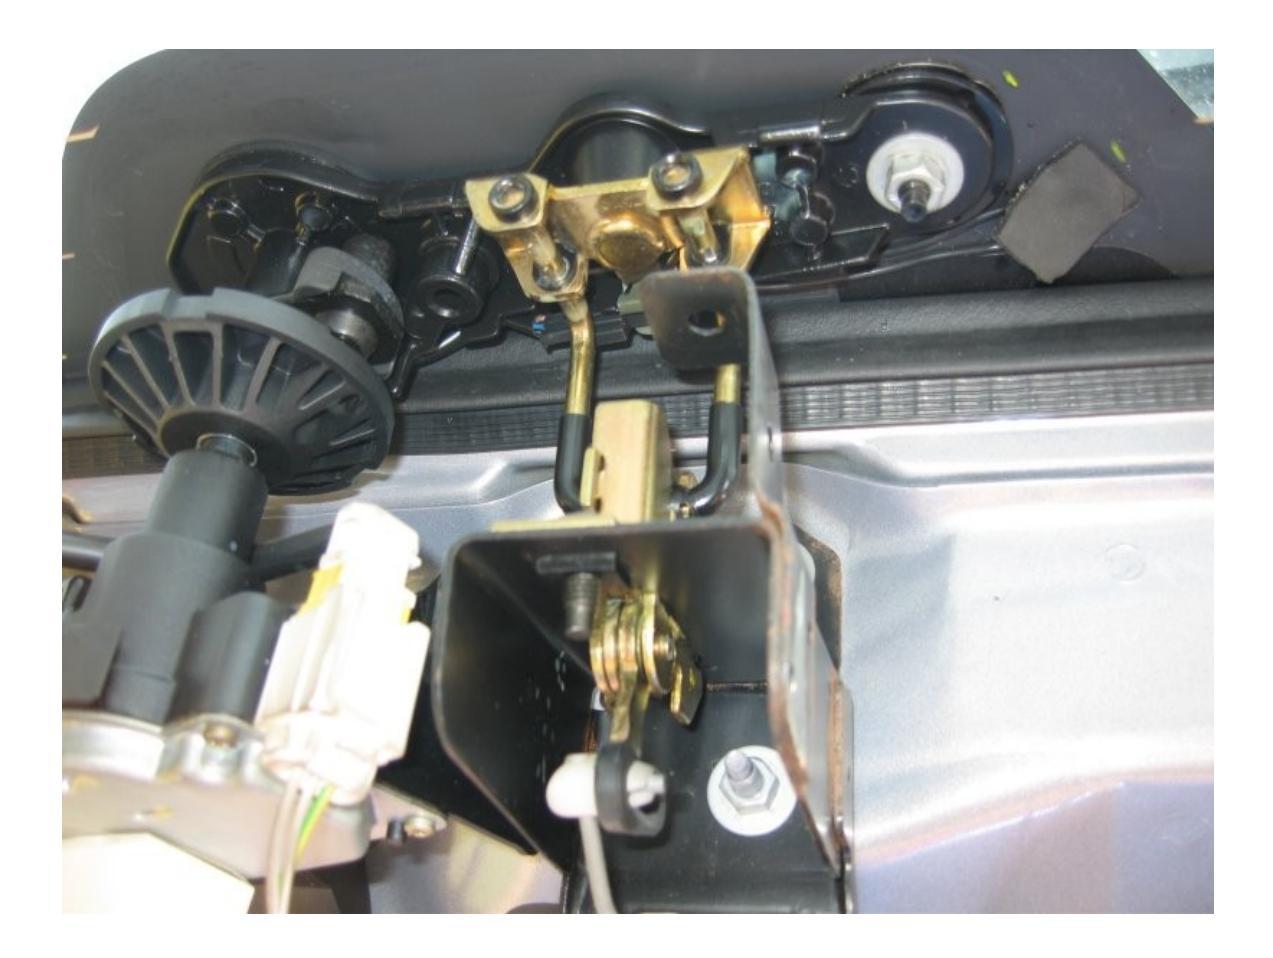
Picture of rear window catch from inside vehicle.

2. You should now be able to open the window by pulling down on the solenoid (note -I removed the top trim in order to photograph the solenoid)

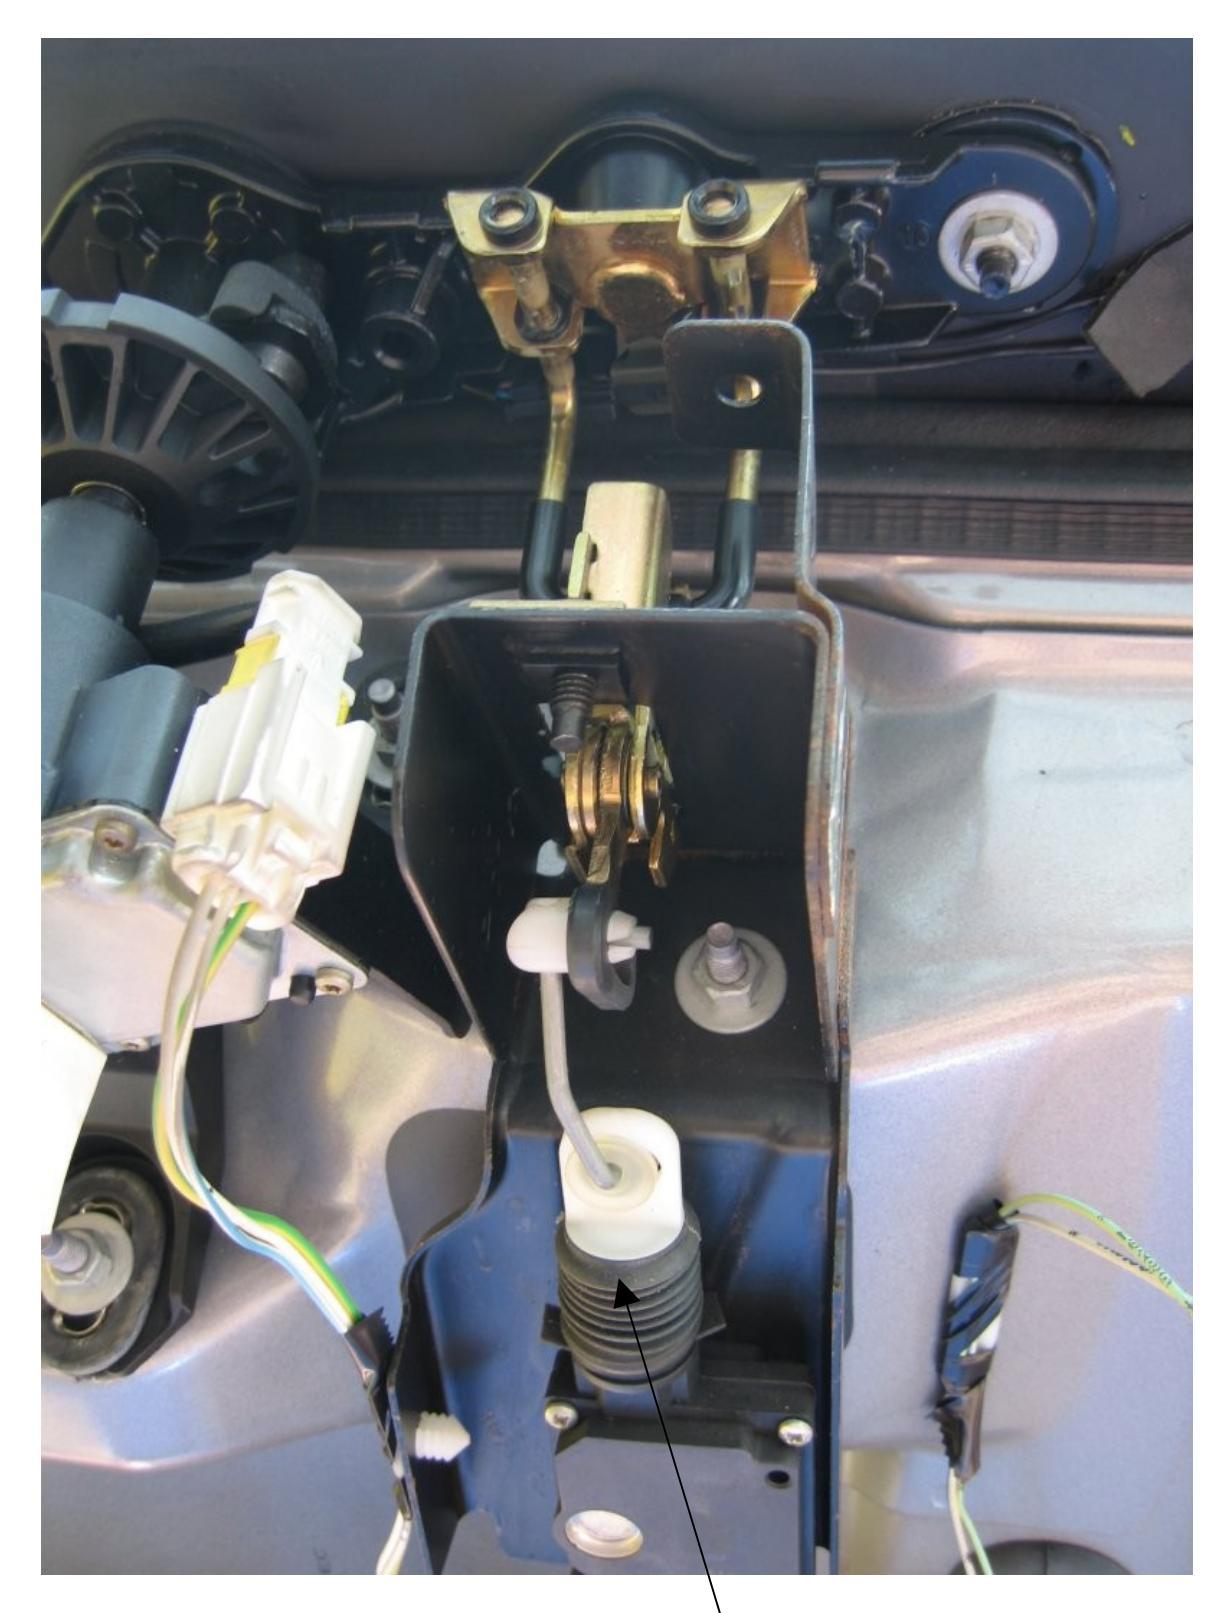
Picture of rear window catch and solenoid

Pull down on solenoid to release window catch.

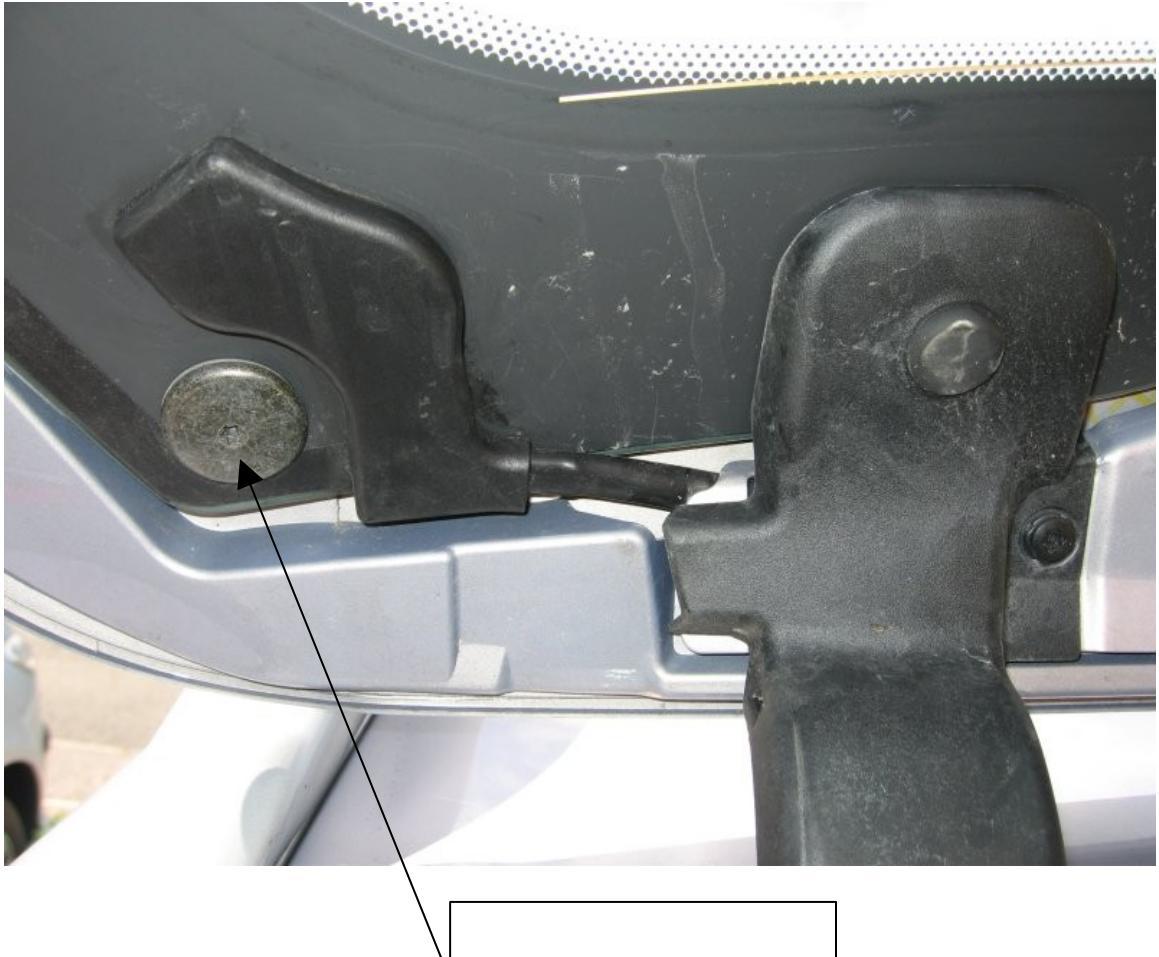
Large flat head T30 bolt

3. The exterior panel housing the high level brake light should now be removed. This is secured with 2 large flat head bolts, 2 ordinary head bolts and 2 plastic clips. The bolts require a T30 Torx bit to remove them.

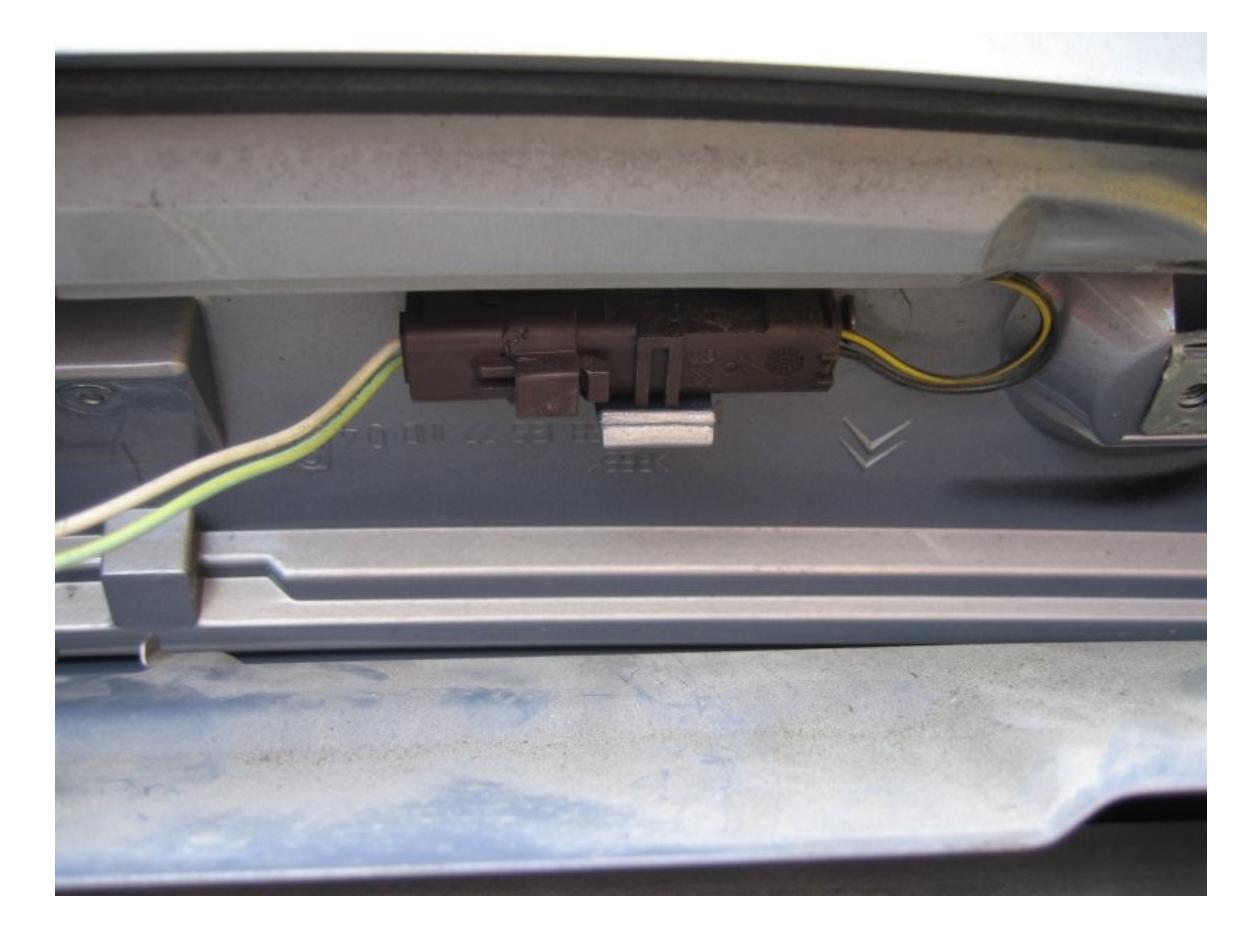
Photo of rear high level brake light connector.

4. Lift the exterior panel housing the high level brake light gently. If the plastic clips do not release easily then remove the two plastic covers running around the hinges. Note that the two "torx screws" that appear to hold the hinge trims on are in fact plastic securing plugs. Gently pull the "torx head" out and the securing plug will come out. Once the hinge covers are removed then the back of the clips securing the high level brake light exterior panel can be compressed and the panel lifted. There is a brown connector visible now the exterior trim is removed (see photo). This should be disconnected as should the rear wash pipe. (Take care with this it looks fragile). The panel can now be removed.

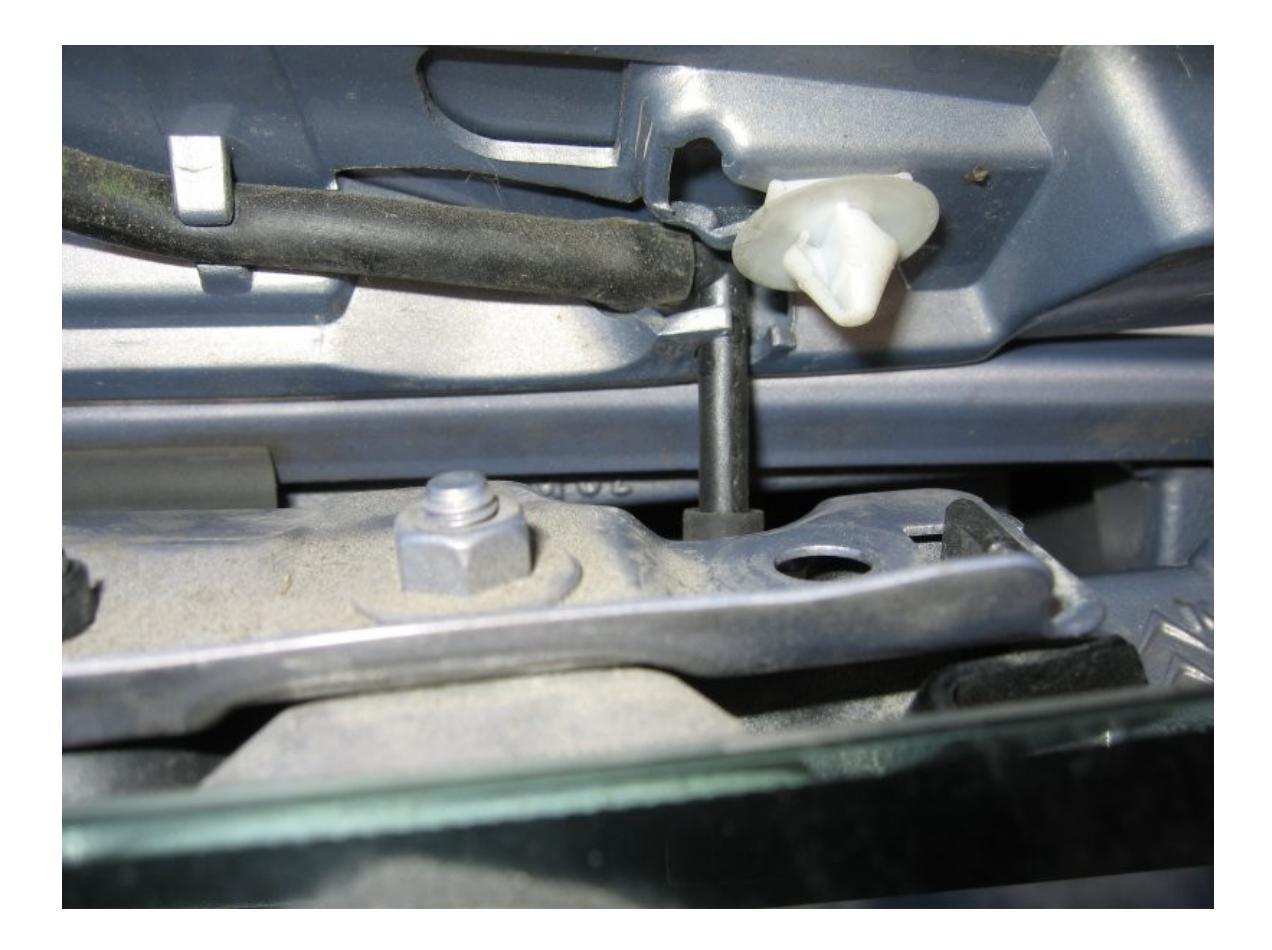
Photo of rear washer pipe.

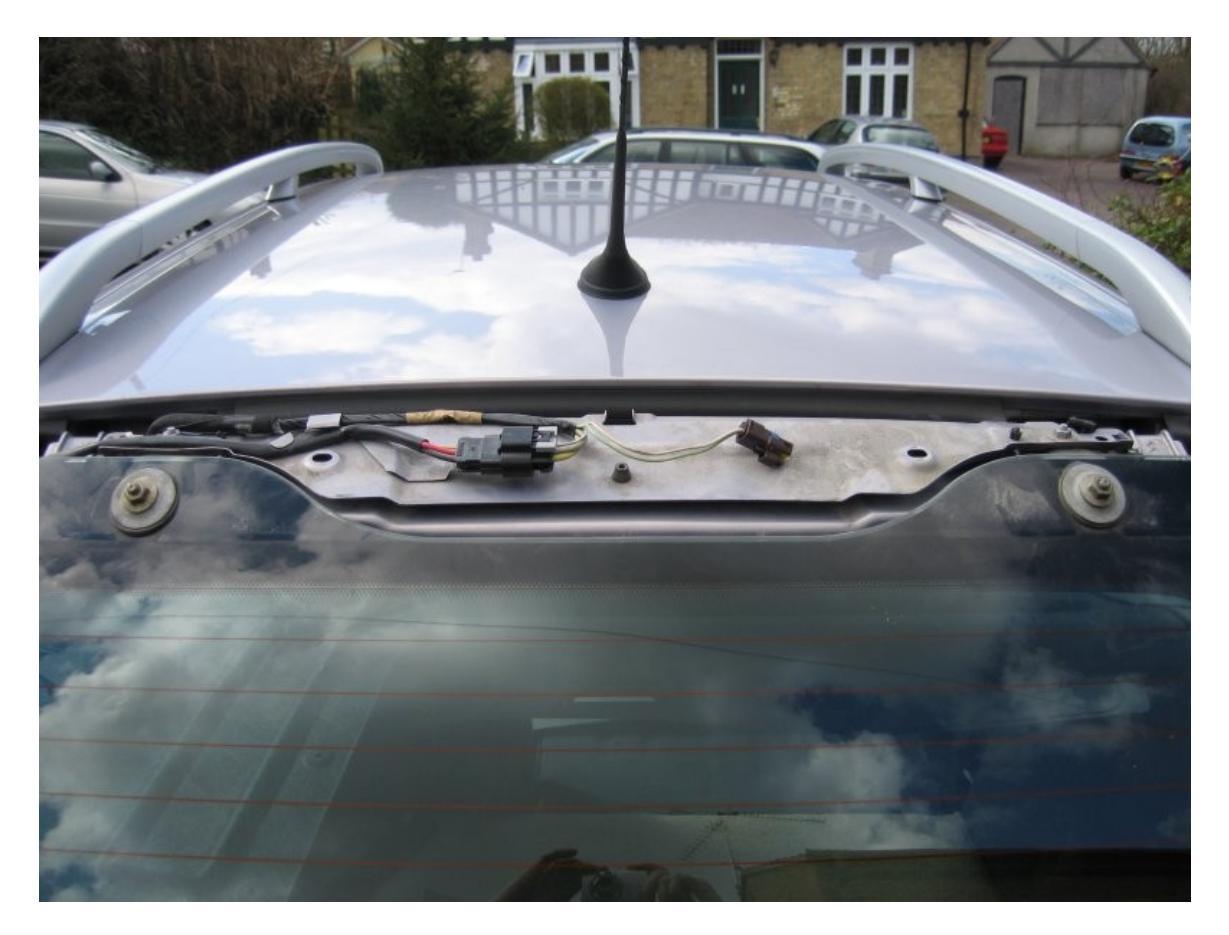
5. The rear of the vehicle should now look like this :-

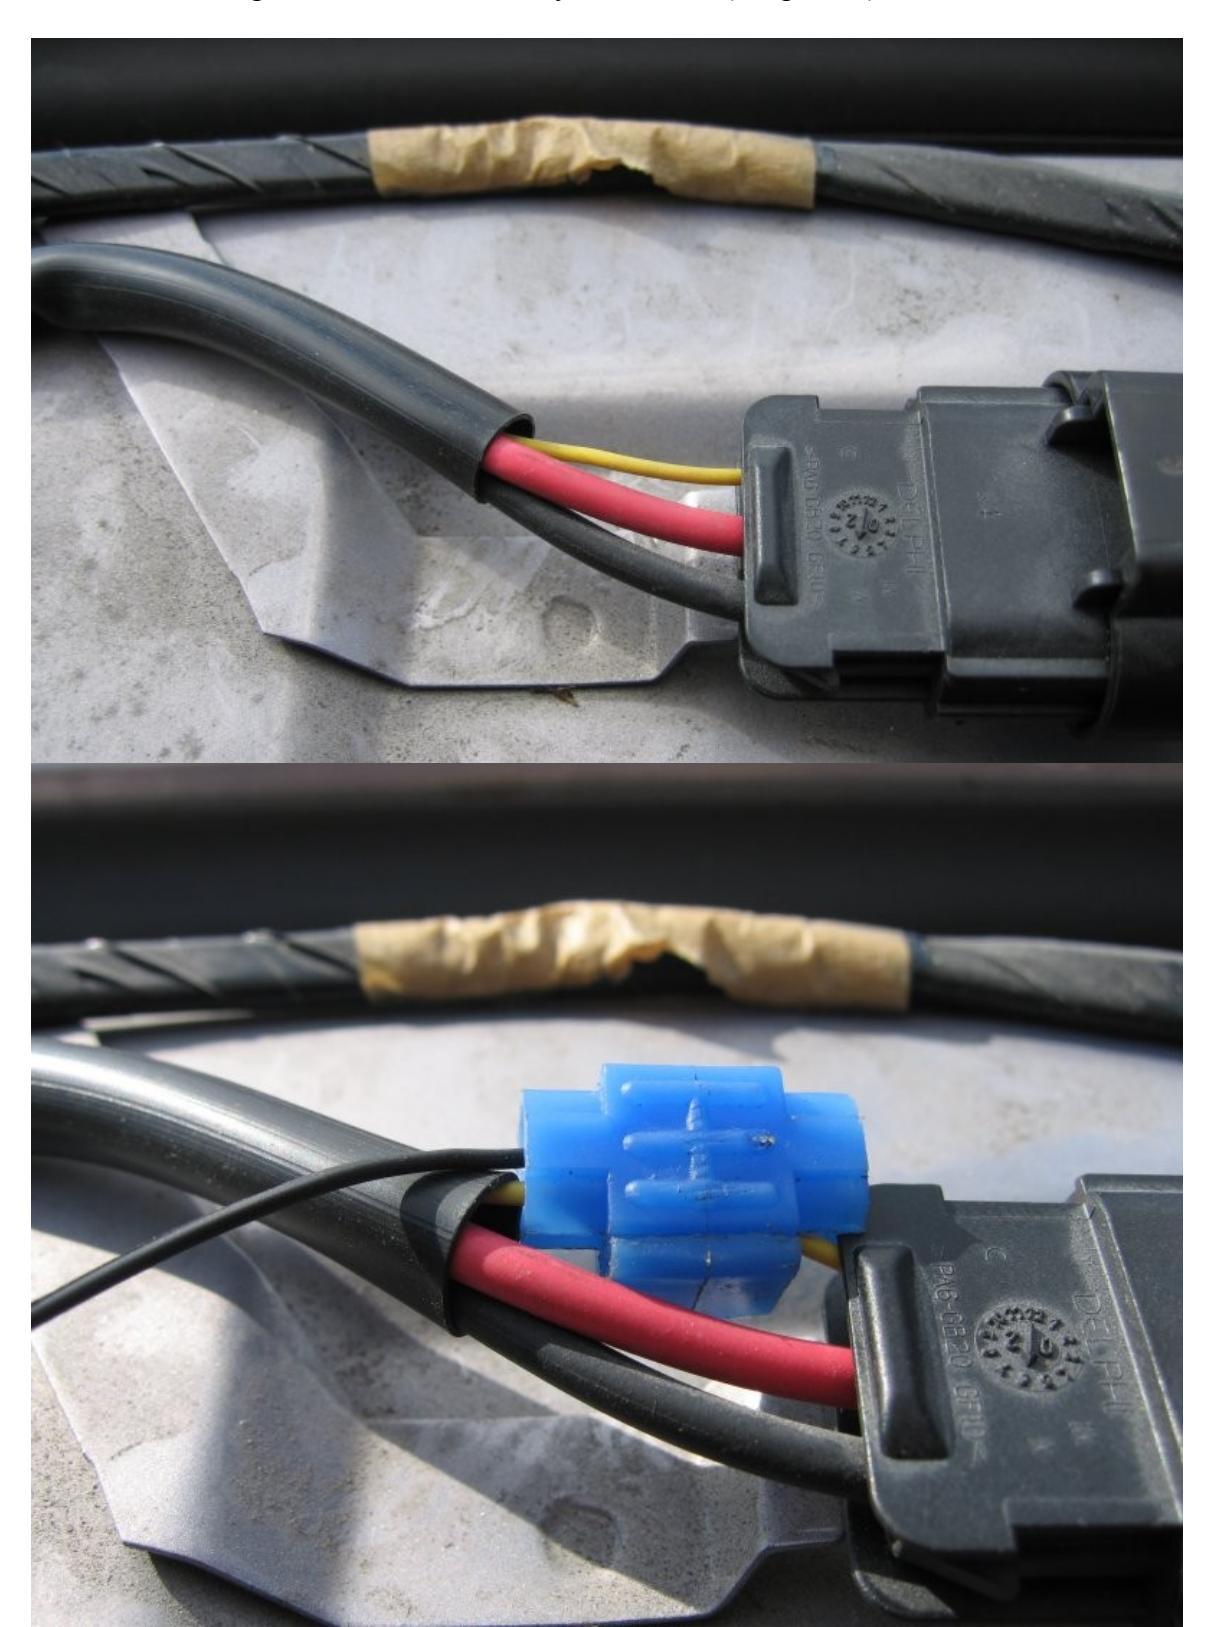
6. The large brown connector takes the power to the heated rear window and also has an extra wire (yellow) for the opening rear window signal. Use a "scotch lock" or similar to attach a 1.5m length of black wire to the yellow wire. (see photos)

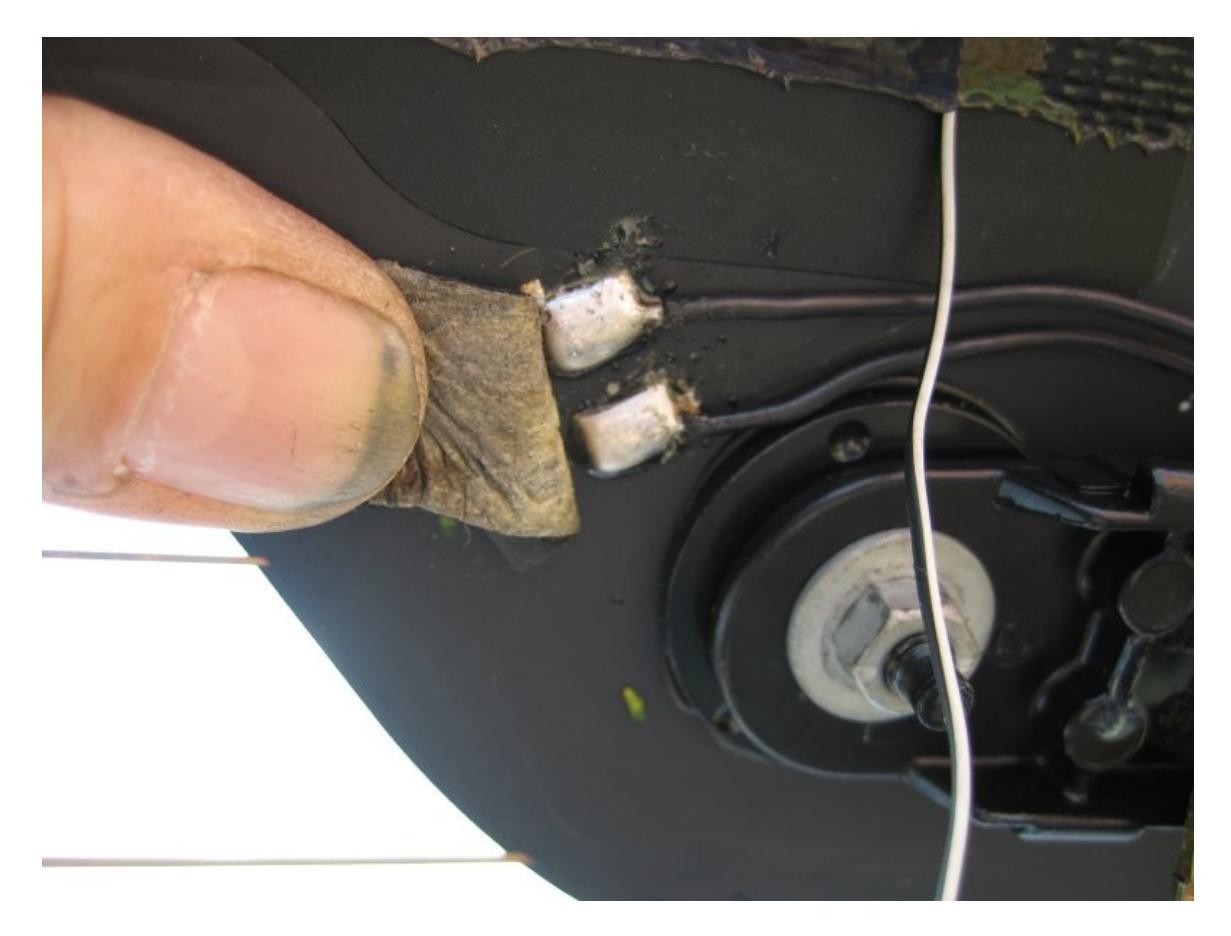
6. If not already removed (to test the switch) remove the grey cover over the window catch and peel back the insulation as shown in the picture to reveal the two solder pads.

7. Now for a quick test. Lock and unlock the cars central locking (in case it has timed out). Connect the end of the black wire to the lower solder pad (lower pad with the window open) and operate the opening switch. The solenoid should operate. If it does not then check that the upper pad is connected to ground using a meter.

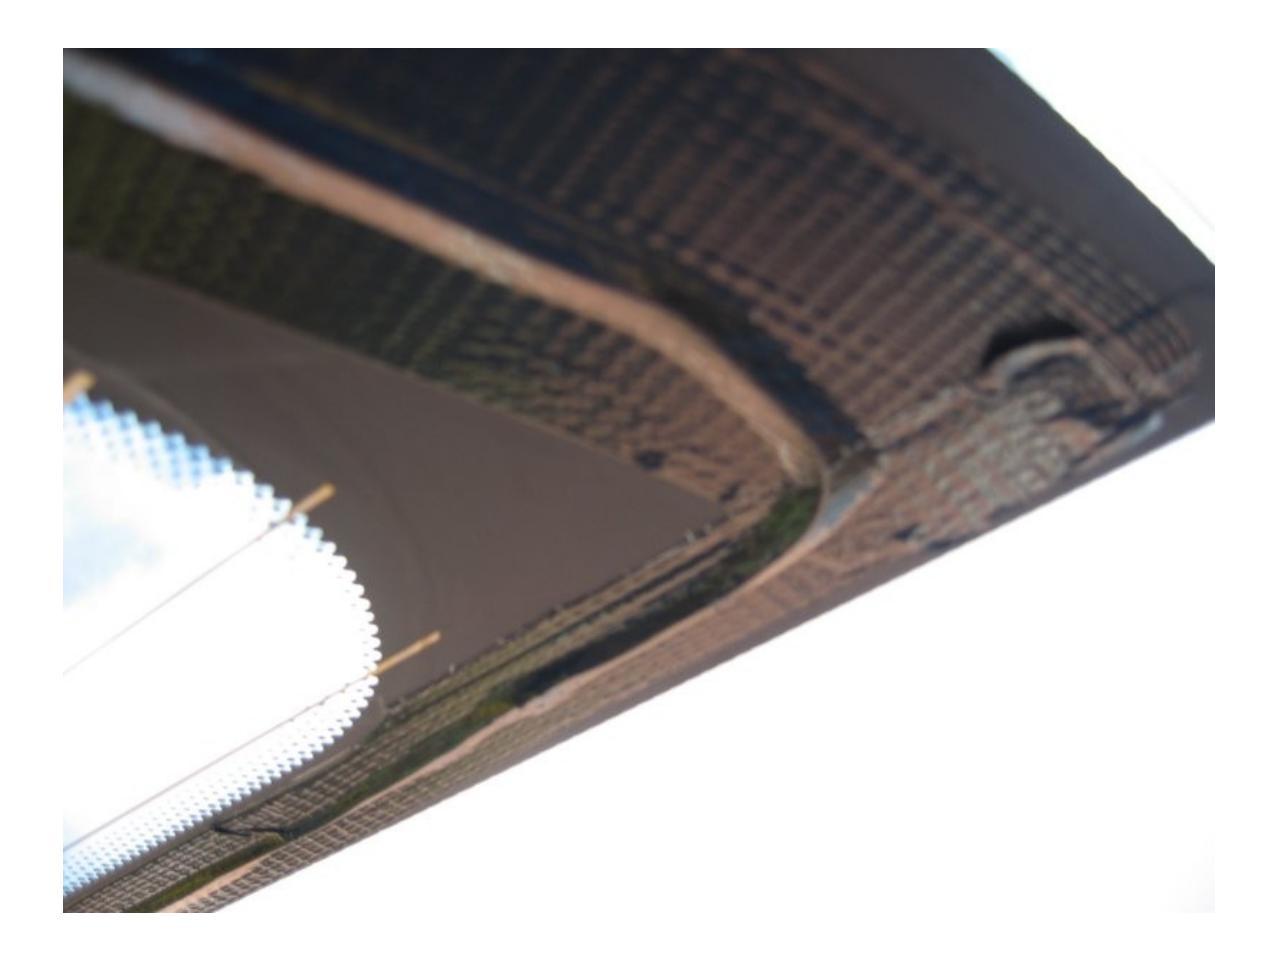
"Duck tape" securing wire to window

11 Using some BLACK "Duck tape" or similar waterproof tape run the wire around the edge of the window securing it under the "Duck tape"

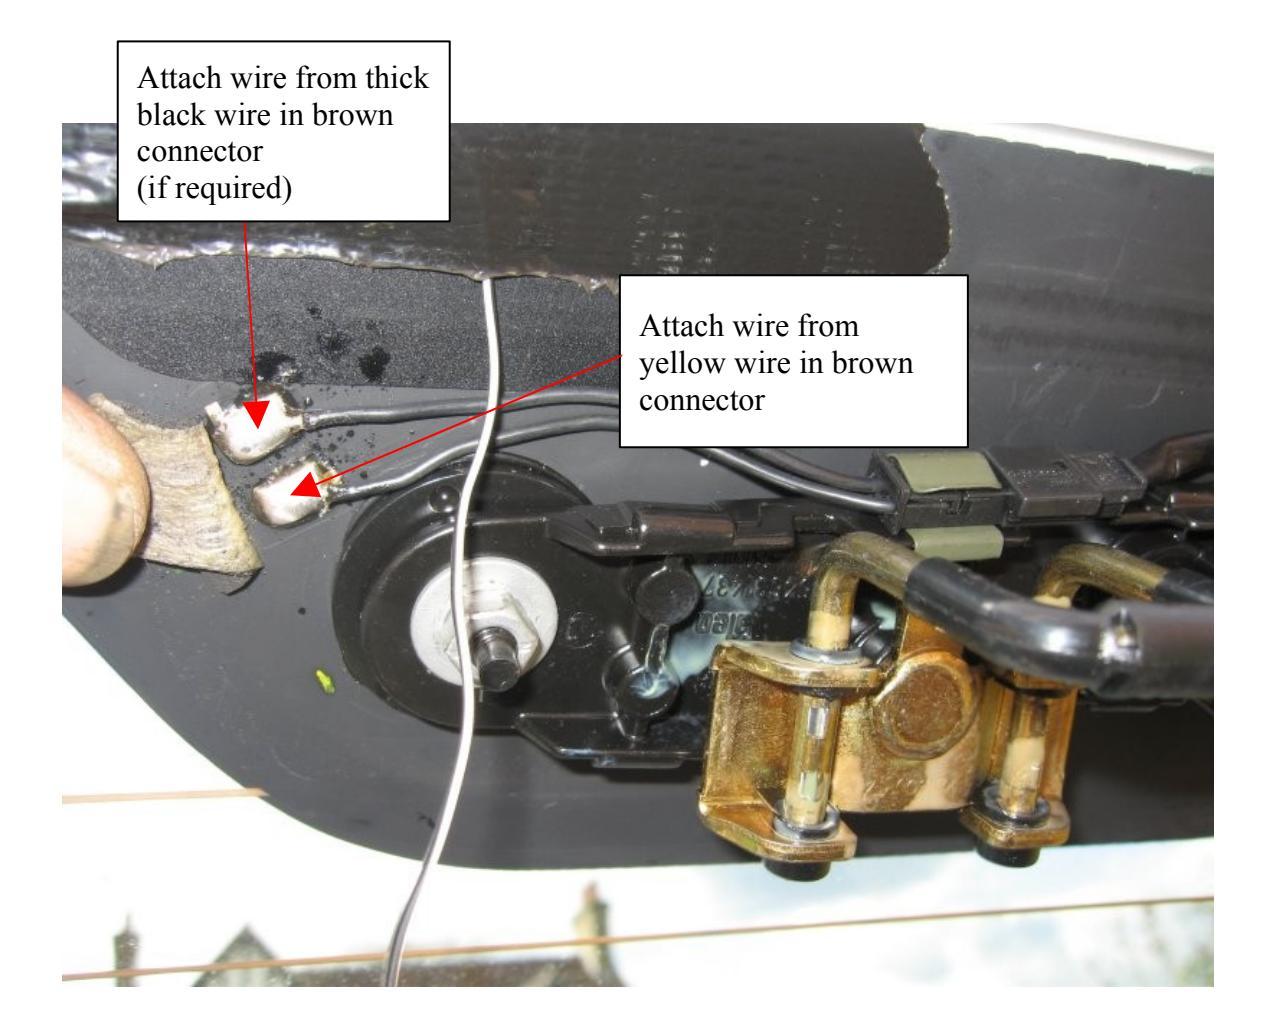
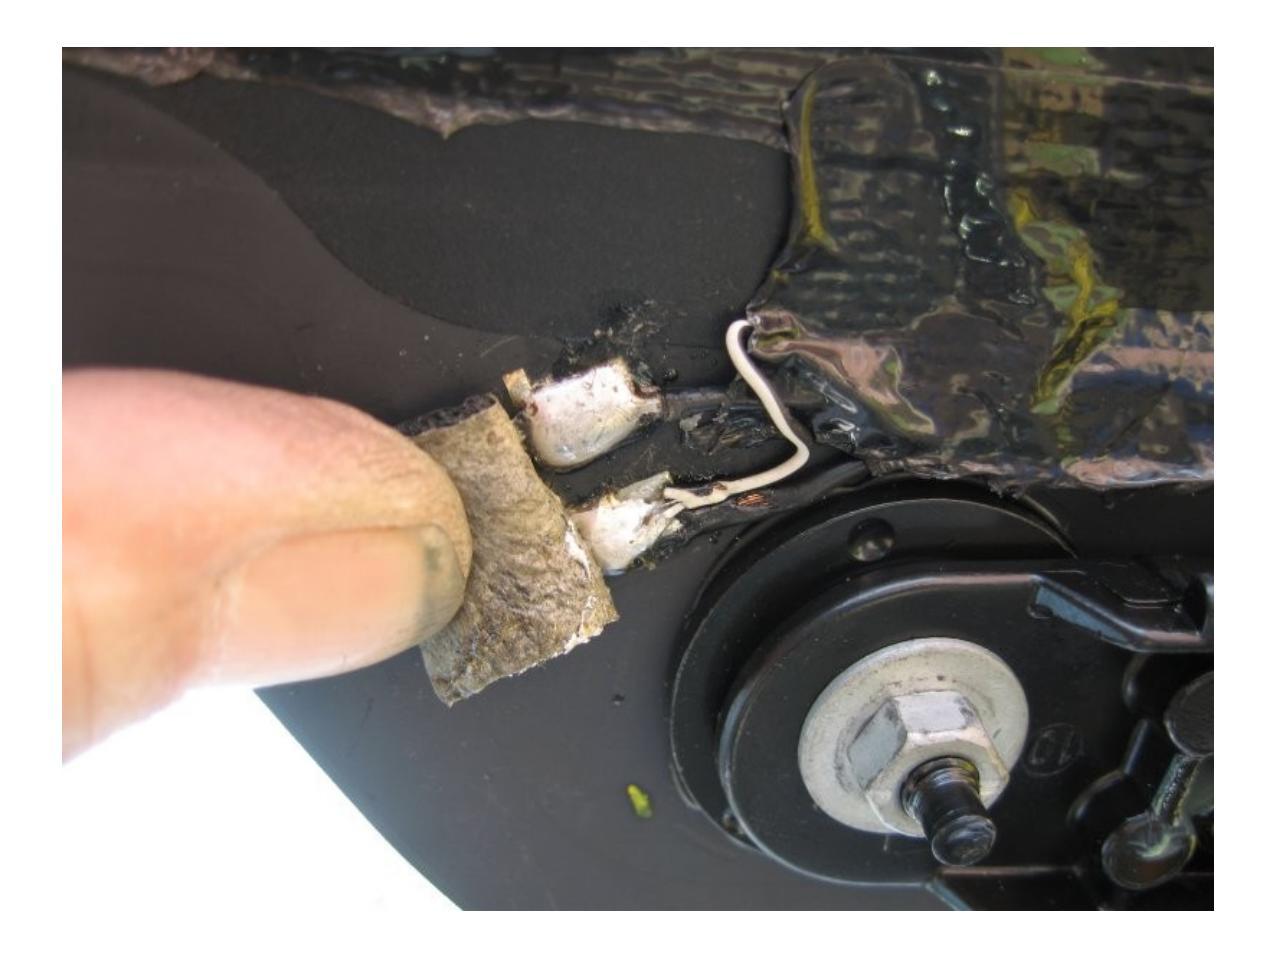
12. Now solder the end of the wire from the yellow wire on the brown connector to the lower pad. If using two replacement wires then solder the wire from the thick black wire in the brown connector to the upper pad.
